Manhole Inspection Summary

Manhole # S45EE_006MH

Insp Date: **3/10/08 1:25 PM**

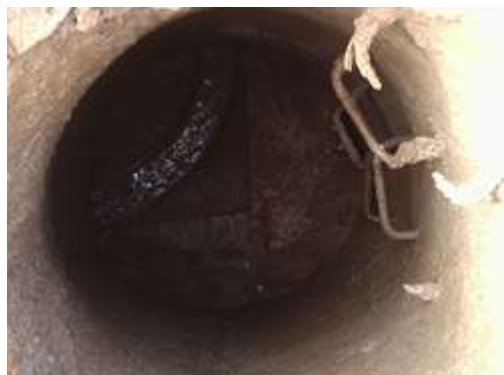
Top View

Frame Offset: **6** (in.) Condition: ☐ Sound ☐ Cracked ☒ **Leaks**

Condition: ☐ Sound ☐ Cracked ☐ Root Intrusion ☒ **Loose Brick** ☐ Deteriorated

Infiltration: ☐ None ☐ Joint ☐ Cracks ☐ Mortar ☐ Roots ☒ **Wall**

Steps Count: **7** Missing: **2** ☒ **Corroded**

Surcharge ☒ **Evidence Of Surcharge** Depth: **11** (ft.) ☐ Active Surcharge Present
